## ARCHITECTURAL DETAILS

## FOR EVERY TYPE OF BUILDING

A Practical Drafting Room Guide for Contractors, Builders, Lumber Dealers, Millmen, Draftsmen, and Architects.

William A. Radford, President of the Radford Architectural Co.; Editor-in-Chief "American Builder" and "Farm Mechanics"; Publisher "Radford's Cyclopedia of Construction" in twelve volumes; "Radford's Estimating & Contracting"; "Details of Building Construction"; "Guaranteed Build-Plans", Etc., Etc.

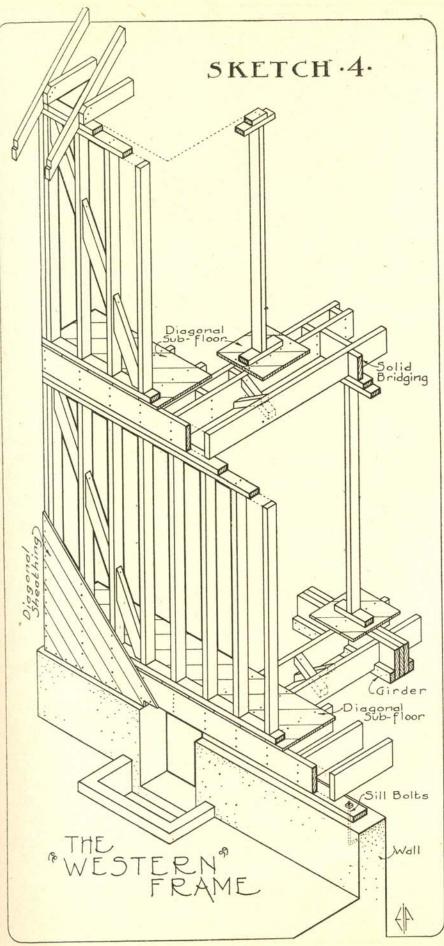
Perspective of All Wood Western Frame. Designed to Prevent Unequal Shrinkage Settlement.

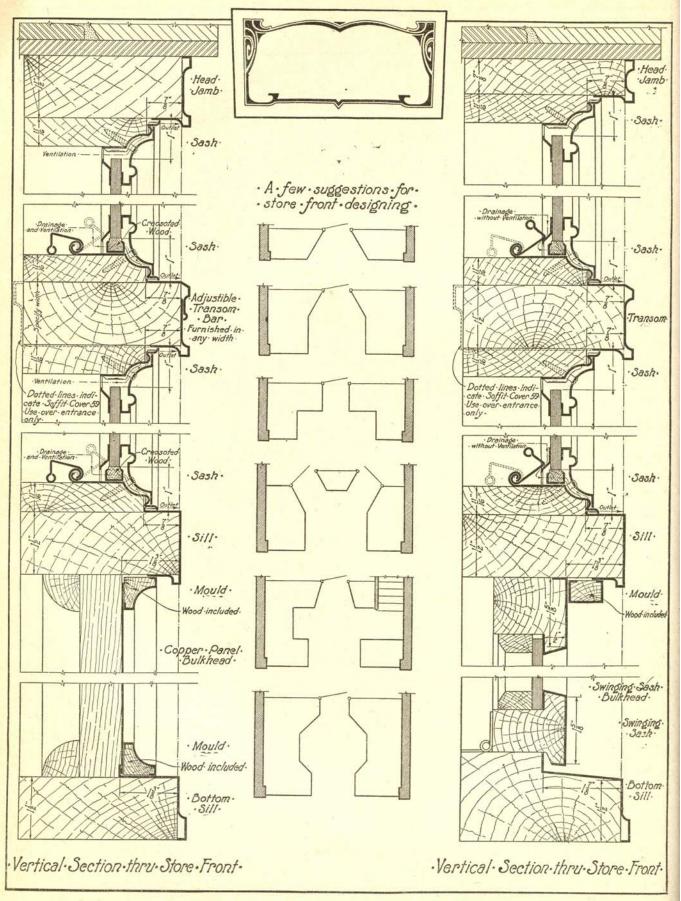
Floor Plans and Typical Details of Construction for Modern Display Windows for Stores.

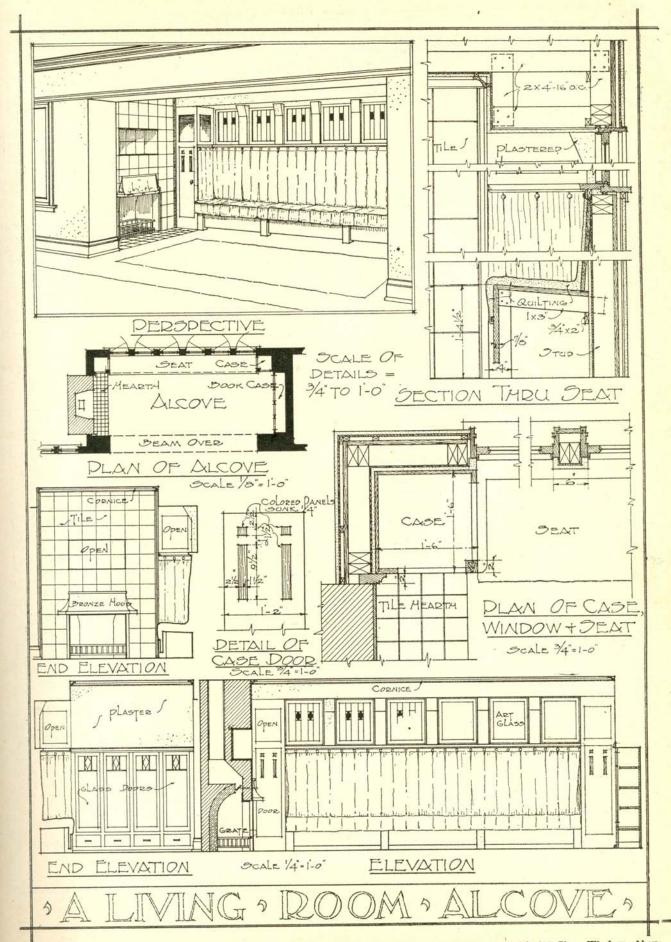
Architect's Sketch Showing Details of Living Room Alcove, Including Comfortable Upholstered Seat with Art Glass Windows Above, Bookcases and Fireplace in Tile with Bronze Hood.

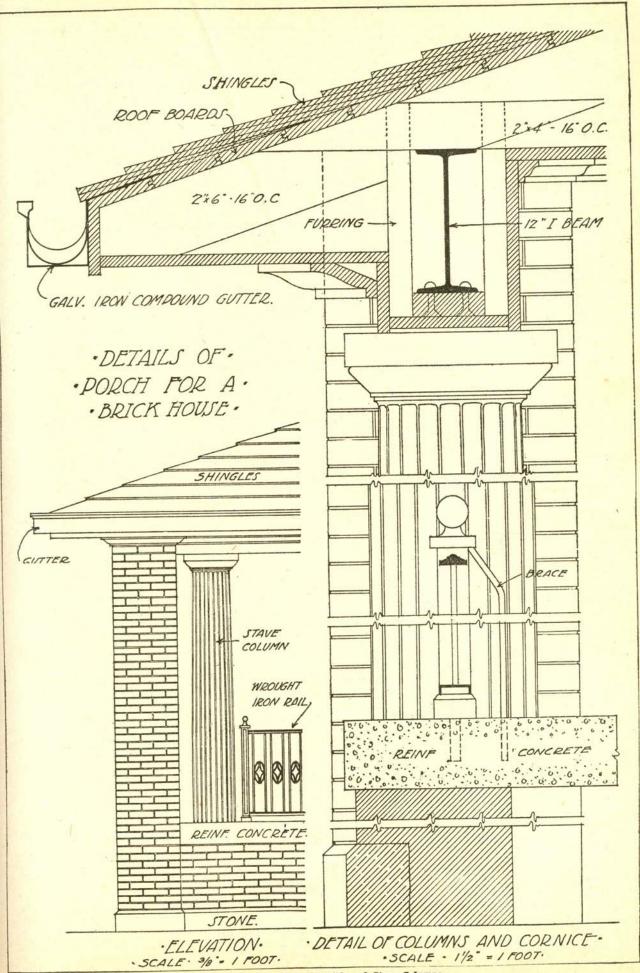
Colonial Porch with Both Brick and Stave Columns.

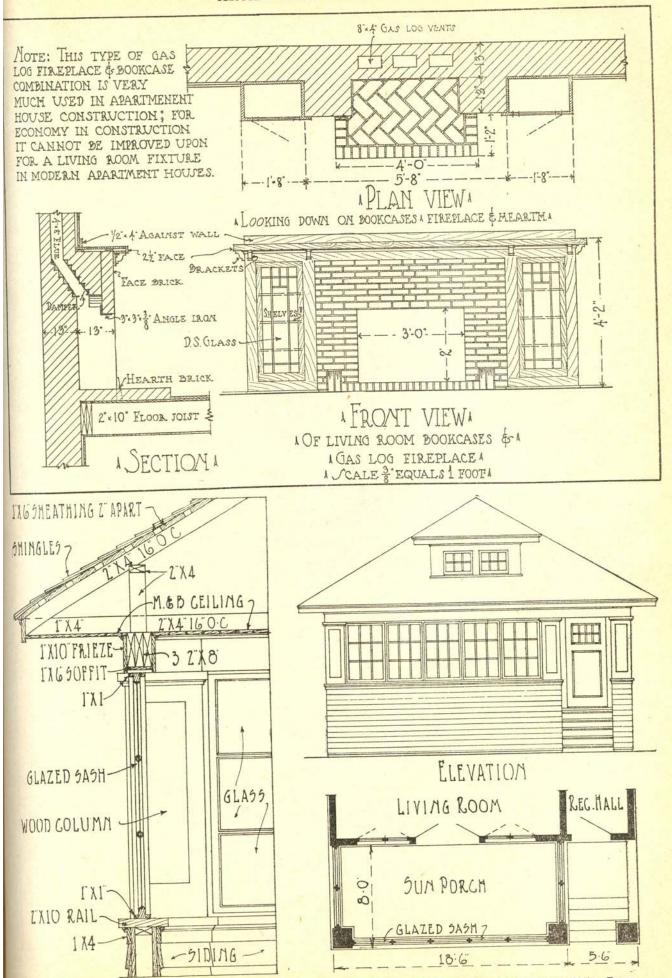
Details of Enclosed Porch and Separate Entry with French Doors and Cement Windows Between Porch and Living Room.

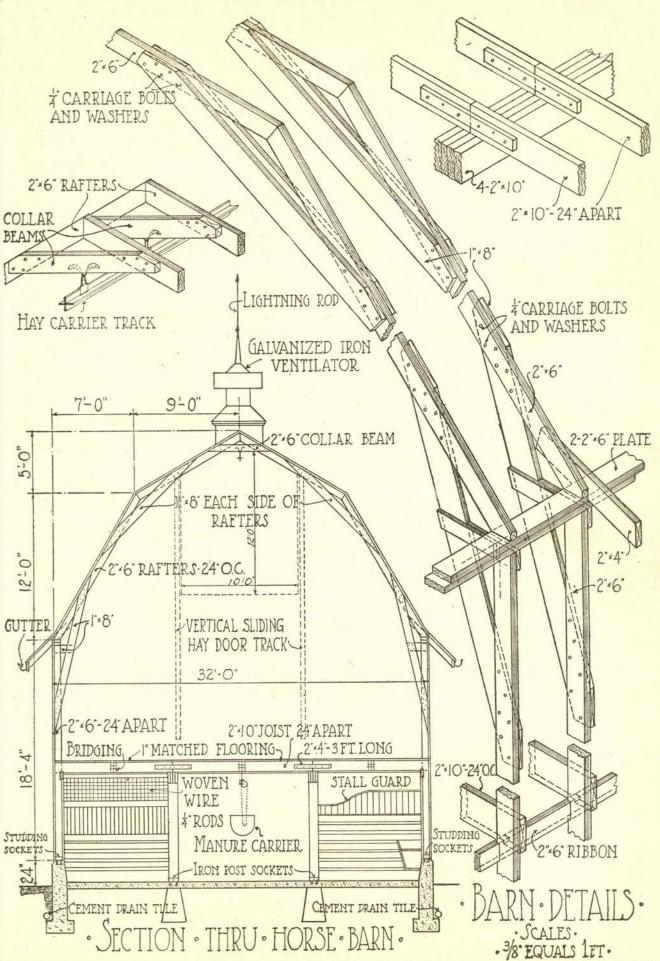
Details of Horse Barn. Roof Is Self-Supporting Plank Frame Construction of the Type Where Every Rafter Forms a Truss. Rafters Spaced on 24-Inch Centers.
